RAPID FIRE COMMUNICATION

Falling Object - Lilly Corporate Center 01-FEB-2018/11:30AM/First Shift

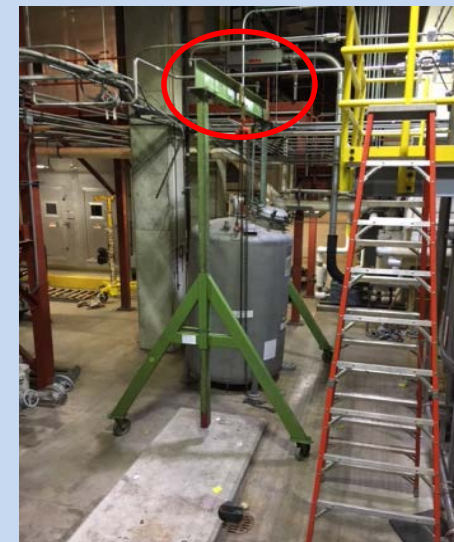
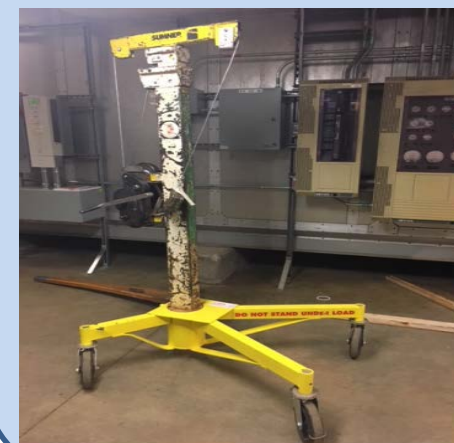
- Mechanical Trade
- LCC/B48A/Mechanical Room DI Water Tank Platform
- Craftsmen were tasked with removing a tank from the M48 A Mechanical room basement. The tank was removed and the crew were dismantling the gantry used to remove the tank. During dismantling, the craftsmen were using a roust-a-bout to support the top beam of the gantry so it could be lowered to the ground. The roust-a-bout was placed under the beam and the beam was tied to it using tie wire. As the beam was being lowered, the wire being used to secure it broke and the beam fell approximately 7ft to the ground.

- Improper rigging used (used tie wires in place of rigging straps)
- Poor job planning (a bigger roust-a-bout was needed for the job)

Beam that fell

- Lesson Learned: The contractors deemed the risk was acceptable to complete the task versus get a different roust-a-bout that was better suited for the job or going back to shop to get appropriate rigging equipment.
- Recommended Follow-up: Develop a safety culture where the workforce feels comfortable to stop work when they feel something is unsafe. Management should encourage employees, of all levels, that it is OK to stop work if something unsafe is being done.
- Recommended Follow-Up: During job site visits, discuss with the craftsmen the hazards of their work and review the planned mitigation practices. Use job plans and/or permits created by the contractor to help talk through the work. Verify the work is in alignment with the plan and the correct tools for the job are being used properly.
