RAPID FIRE COMMUNICATION

Potential SIF – Electrical/ Lilly Corporate Center June 2018

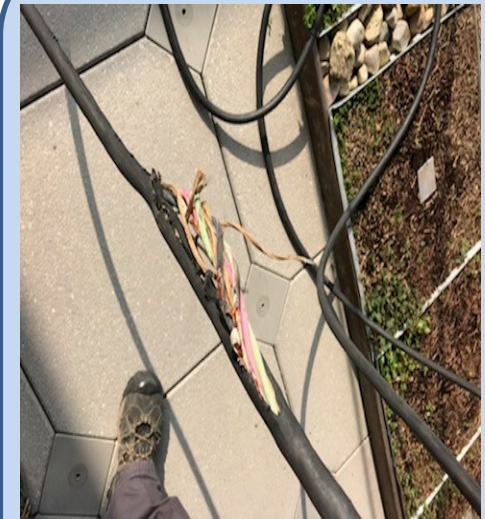
- Iron Workers
- LCC – M74 Façade Project
- While using a GBL powered work platform, two occurrences of 480V power cable damage occurred. Both events were the result of the power cord being damaged due to the movement of the platform. The first event; the power cord was not placed in the basket, attached to the platform, designed to hold the cord while platform is moving. The cord hung down from the platform and eventual the weight/pressure resulted in the cord insulation being pulled away, exposing live wires, and arcing. The second event; the power cord was damaged when the platform pinched the cord against the structure. While the platform was moving laterally, the cord hung down between the moving platform carriage and the structural steel resulting in the power cord being pinched and cut. In both events the fuses were blown, no workers experienced electric shock.

- The hazards of the pinch points and placement of the power cord were not identified in the use and movement of the platform.
- The training module was not specific and did not call out the differences between the two GBL systems.

The power cable for the work platform is capable of moving with the system horizontally and vertically. Cable was not properly protected resulting in damage to cord.

- Ensure workers are adequately trained on the tools and equipment that will be used for completion of tasks. If new or unique equipment is to be used on a job, equipment specific training is to be provided to ensure operators understand proper controls, equipment operating hazards, and how to mitigate the hazards.
- Engineer controls, to remove human error and potential hazards, should always be a top priority when implementing corrective measures. In this situation, the project relocated the power supply to keep the power cable out of the line of fire instead of relying on a person to monitor the cable as the platform was moved.
